HELMholtz Symposium on Materials And Coatings for High Temperatures  
7<sup>th</sup>- 8<sup>th</sup> April, 2016

## SOLID PARTICLE EROSION OF STANDARD AND ADVANCED THERMAL BARRIER COATINGS

F. Cernuschi, C. Guardamagna, L. Lorenzoni

Ricerca sul Sistema Energetico - RSE S.p.A.

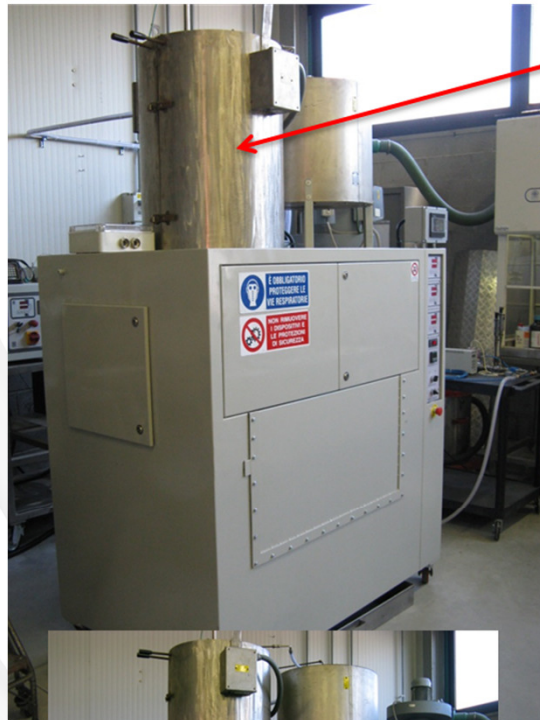
## RSE SPE Jet Tester

**Main furnace with the  
coil for air inside**

- Impact angles 30°, 45°, 60° and 90°
- Temperature RT to 950°C.
- Velocity up to 250m/s.

In agreement with the ASTM G211-2014 Standard

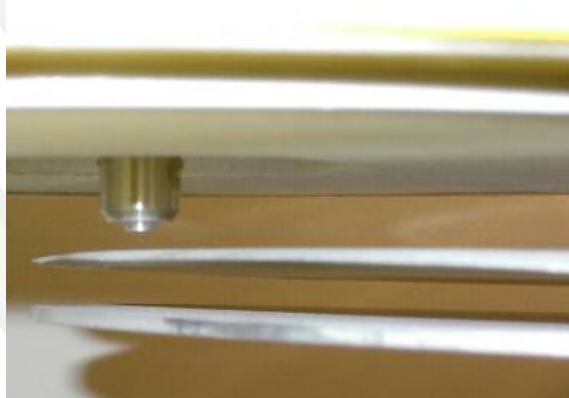
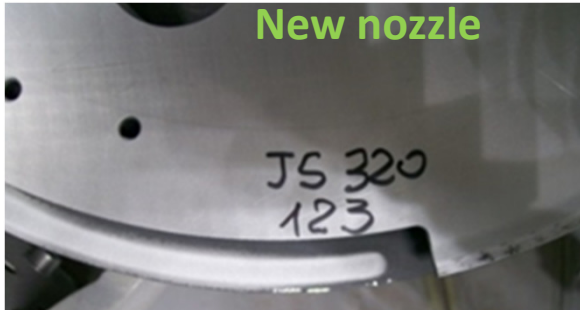
New nozzle

Five windows uniformly distributed along the upper disk to increase the statistics

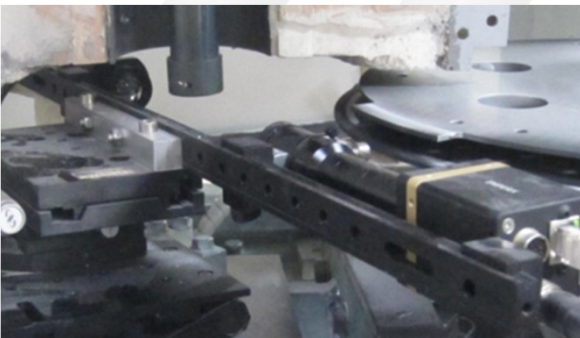
Laser Doppler Velocimetry

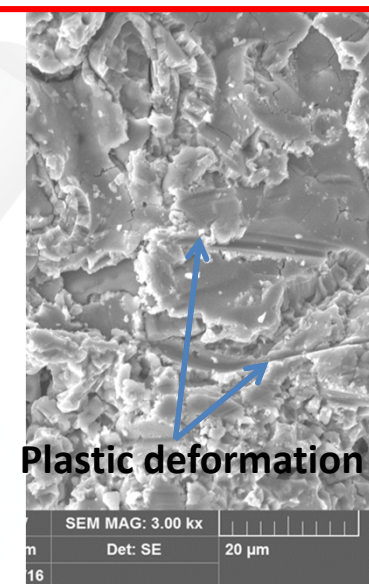
Crack propagation and fracture of TBC splats and cluster of splats seems to be the main damage mechanisms when coarse powder is used as erodent. Ductile behaviour of TBC can be still observed. A significant embedding of erodent particle can be observed. **Mode II and III**
