Manufacturing and Design of nonoxide Ceramic Matrix Composites for Gas Turbine Applications

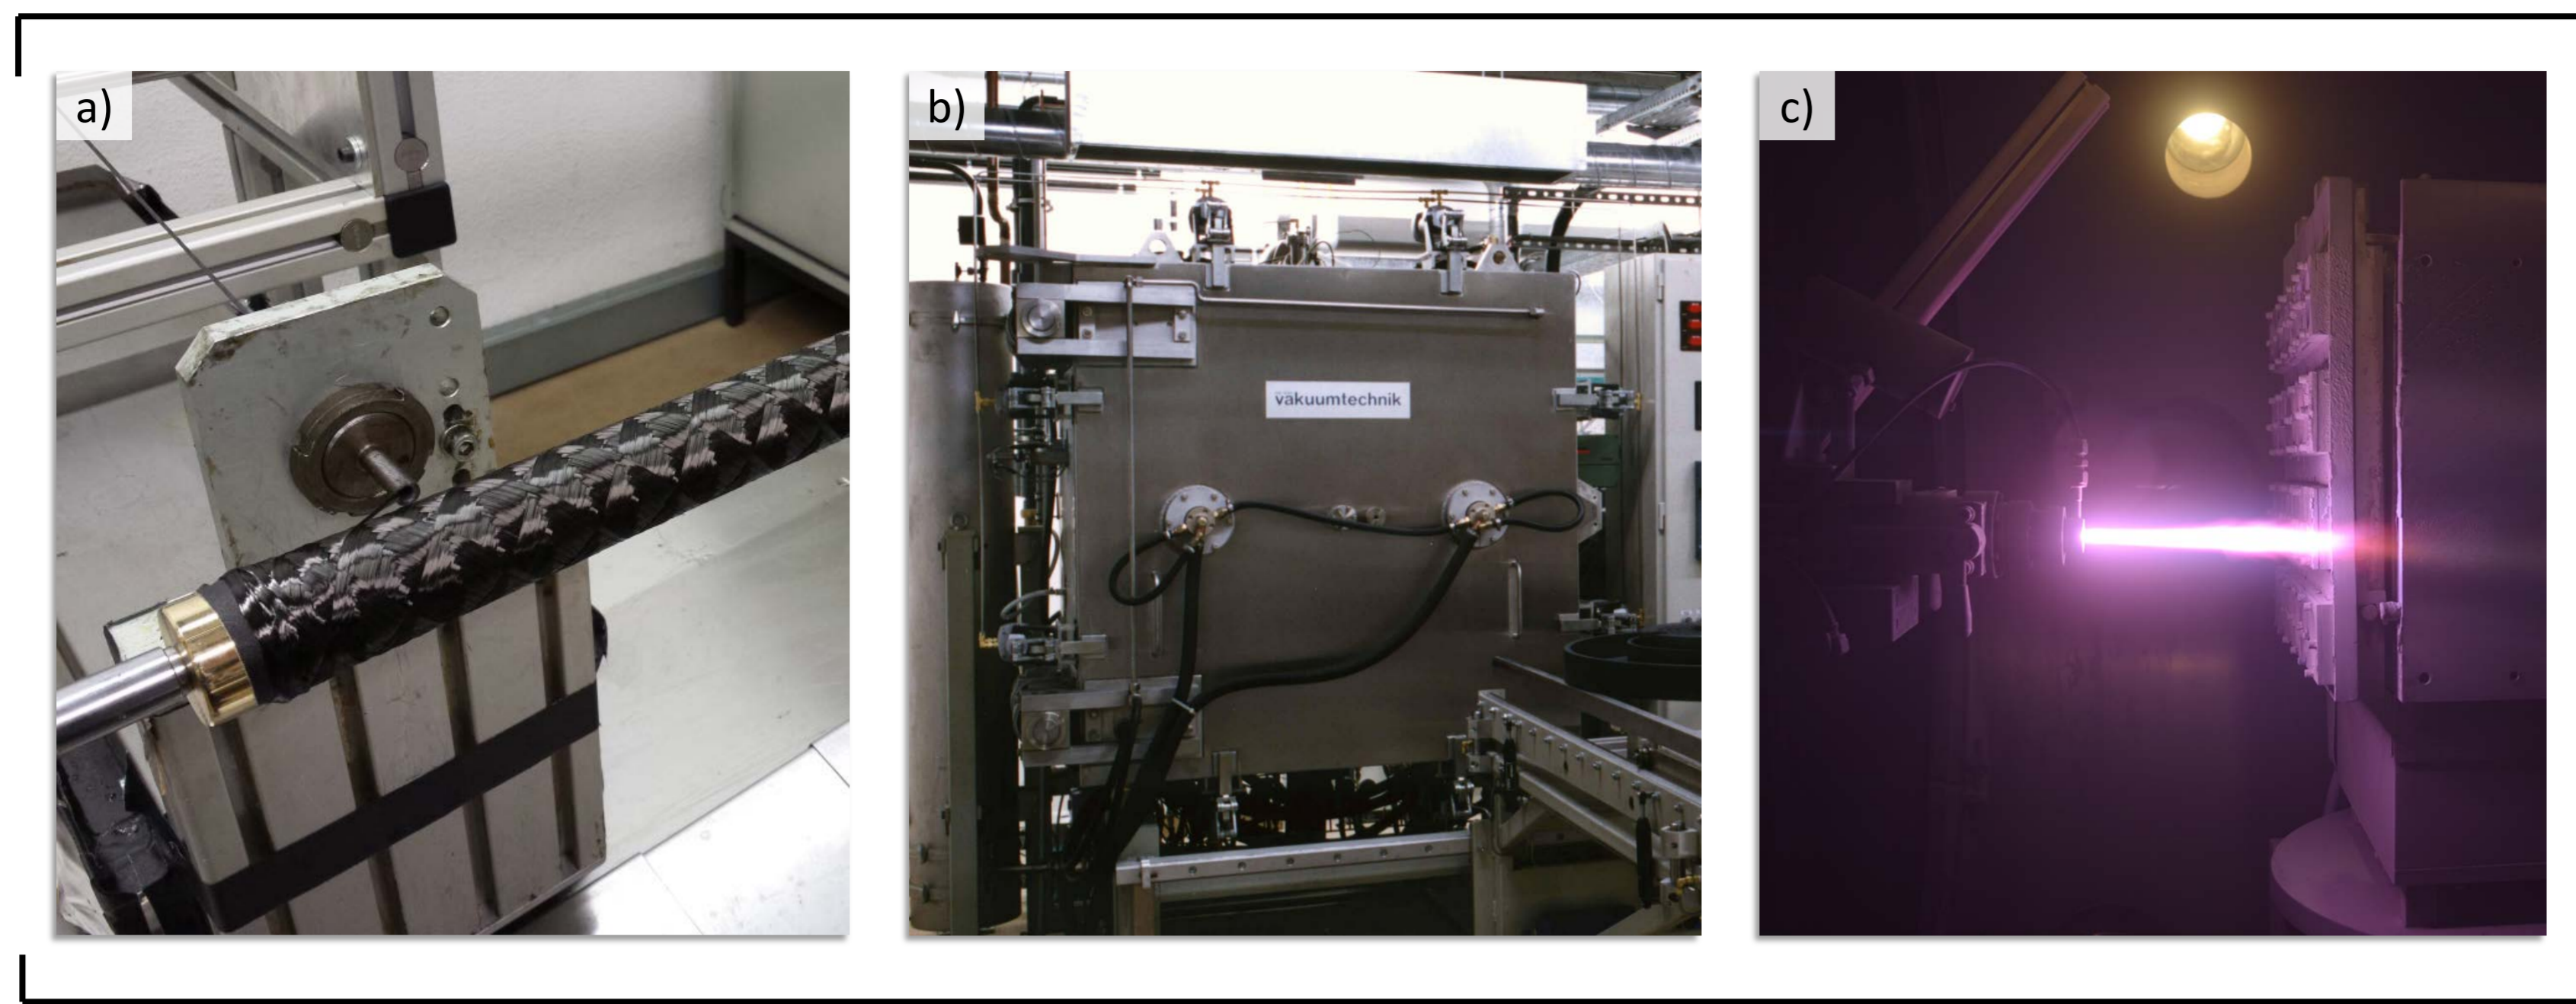
Fig. 1: Different techniques to manufacture nonoxide CMCs at DLR: a) filament winding process; b) furnace for pyrolysis and siliconisation; c) plasma spraying of environmental barrier coatings on CMCs

- To improve the oxidation resistance, a plasma sprayed yttrium silicate environmental barrier coating is under development (Fig. 1c)
- Liquid silicon infiltration (LSI) is a technique with short process times to obtain composites with low porosity. In this 3-step process, a phenolic resin based carbon precursor is infiltrated in fibre preforms and thermally cured and pyrolysed. Liquid silicon infiltration leads to a reaction of the carbon matrix with silicon to silicon carbide

To improve the oxidation resistance, a plasma sprayed yttrium silicate environmental barrier coating is under development (Fig. 1c)

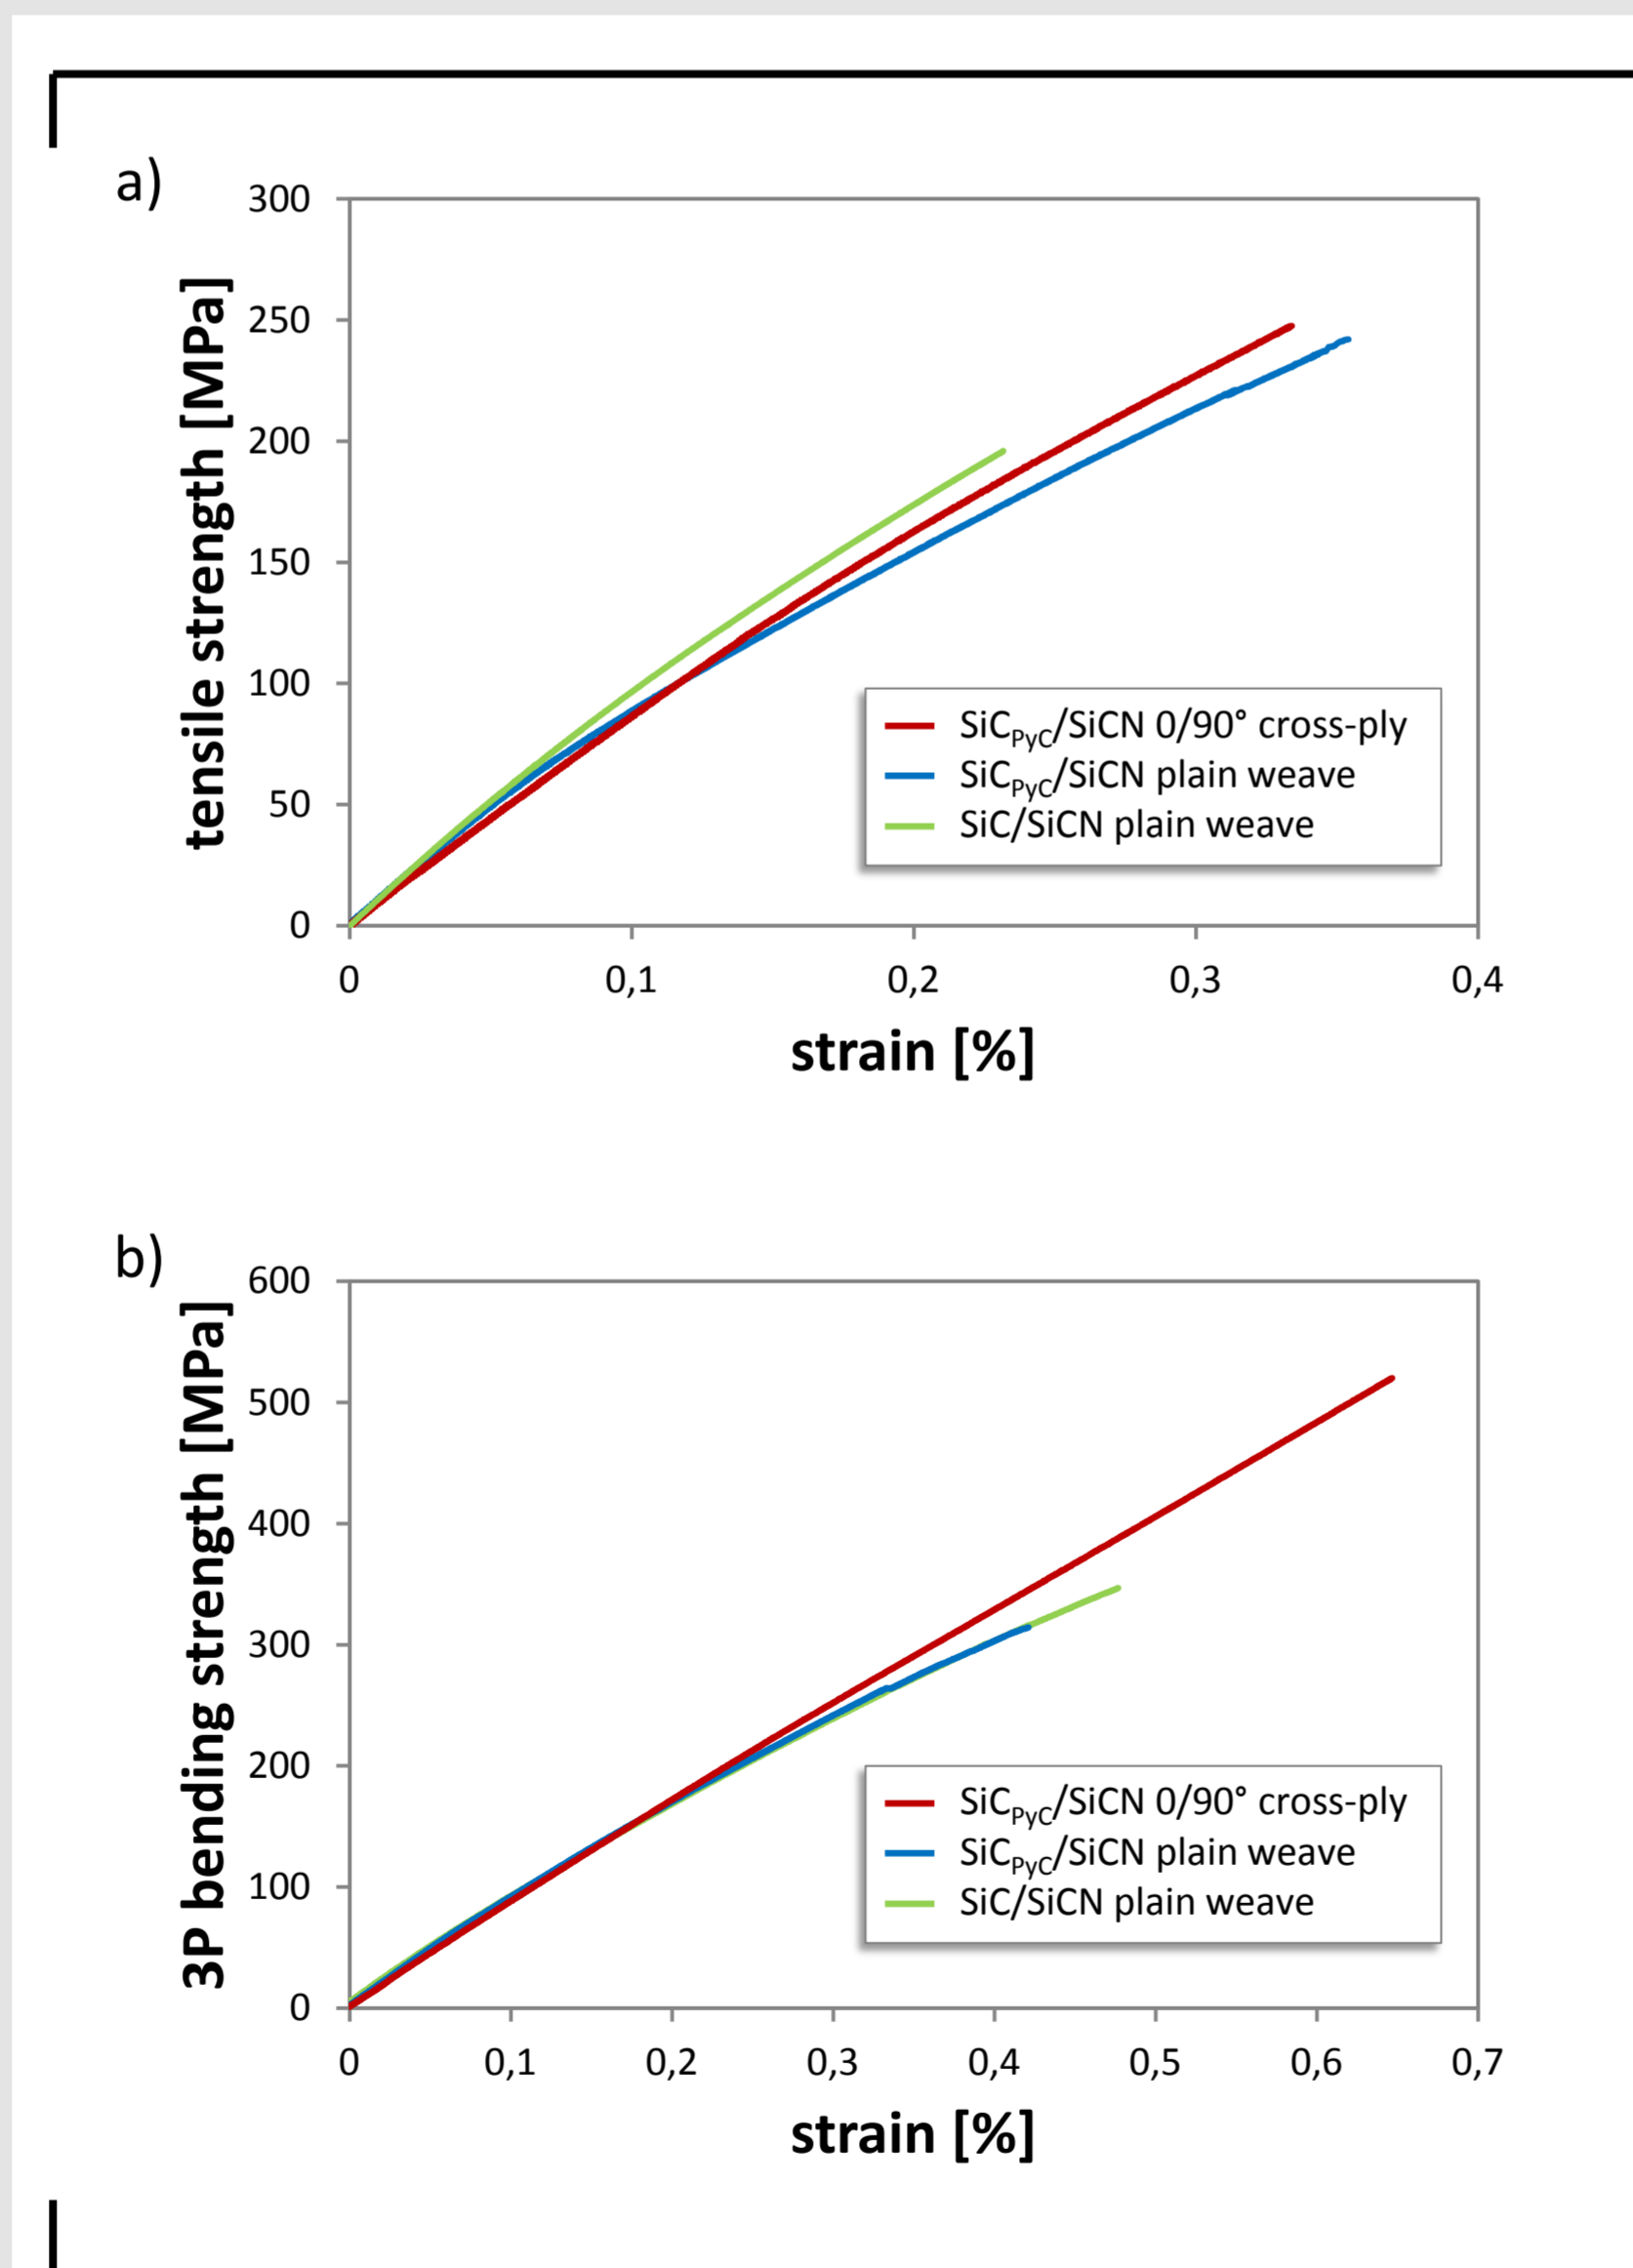
Fig. 2: mechanical properties of PIP SiC/SiCN composites based on the Tyranno SA3 fibres with 33% fibre volume content at room temperature: a) tensile strength; b) bending strength via 3PB-test
