Fatigue Testing of Ni-based Superalloys for Gas Turbine Blades C. Meid, A. Kostka, and M. Bartsch

Research Objectives

Characterizing the influence of microstructural features on elementary fatigue mechanisms under high temperature fatigue for single crystal (SX) superalloys

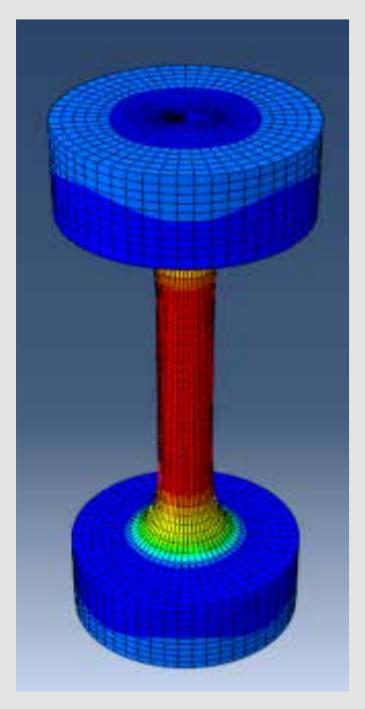
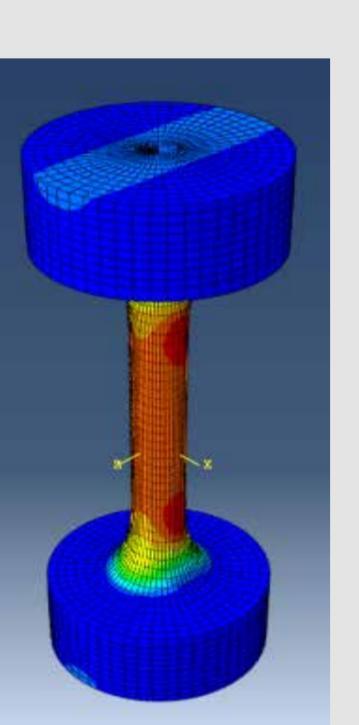
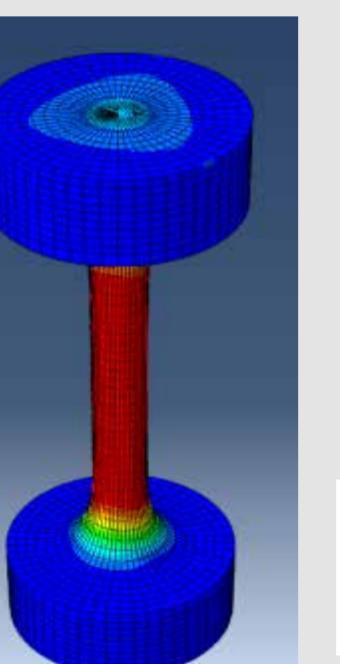
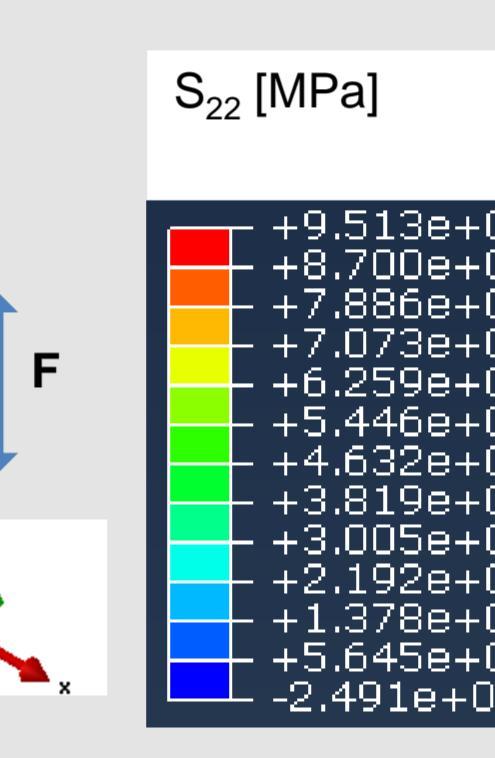
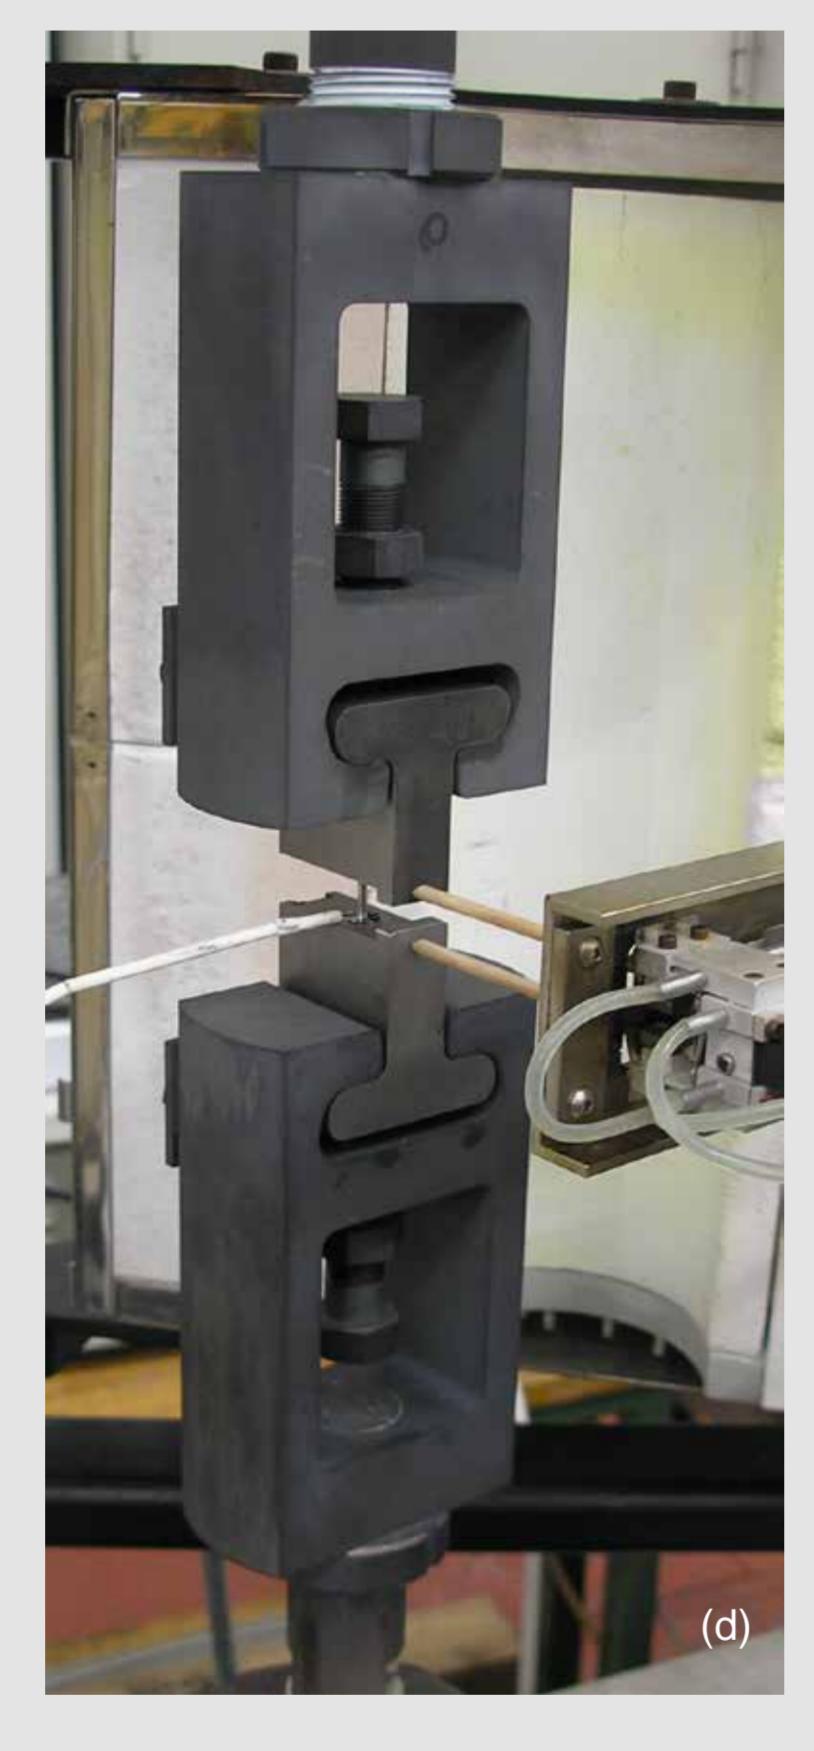
Figure 1: Development of miniaturized high temperature LCF testing (a) specimen design by means of FEM calculation considering different crystallographic orientations, (b) specimen and cast slab, (c) miniature specimen and standard specimen and (d) fixture for high temperature LCF

Miniature specimens and test fixture are developed for Low Cycle Fatigue (LCF) testing at high temperatures. Miniaturization allows preparing of specimens with different crystallographic orientations from cast slabs (Fig. 1).

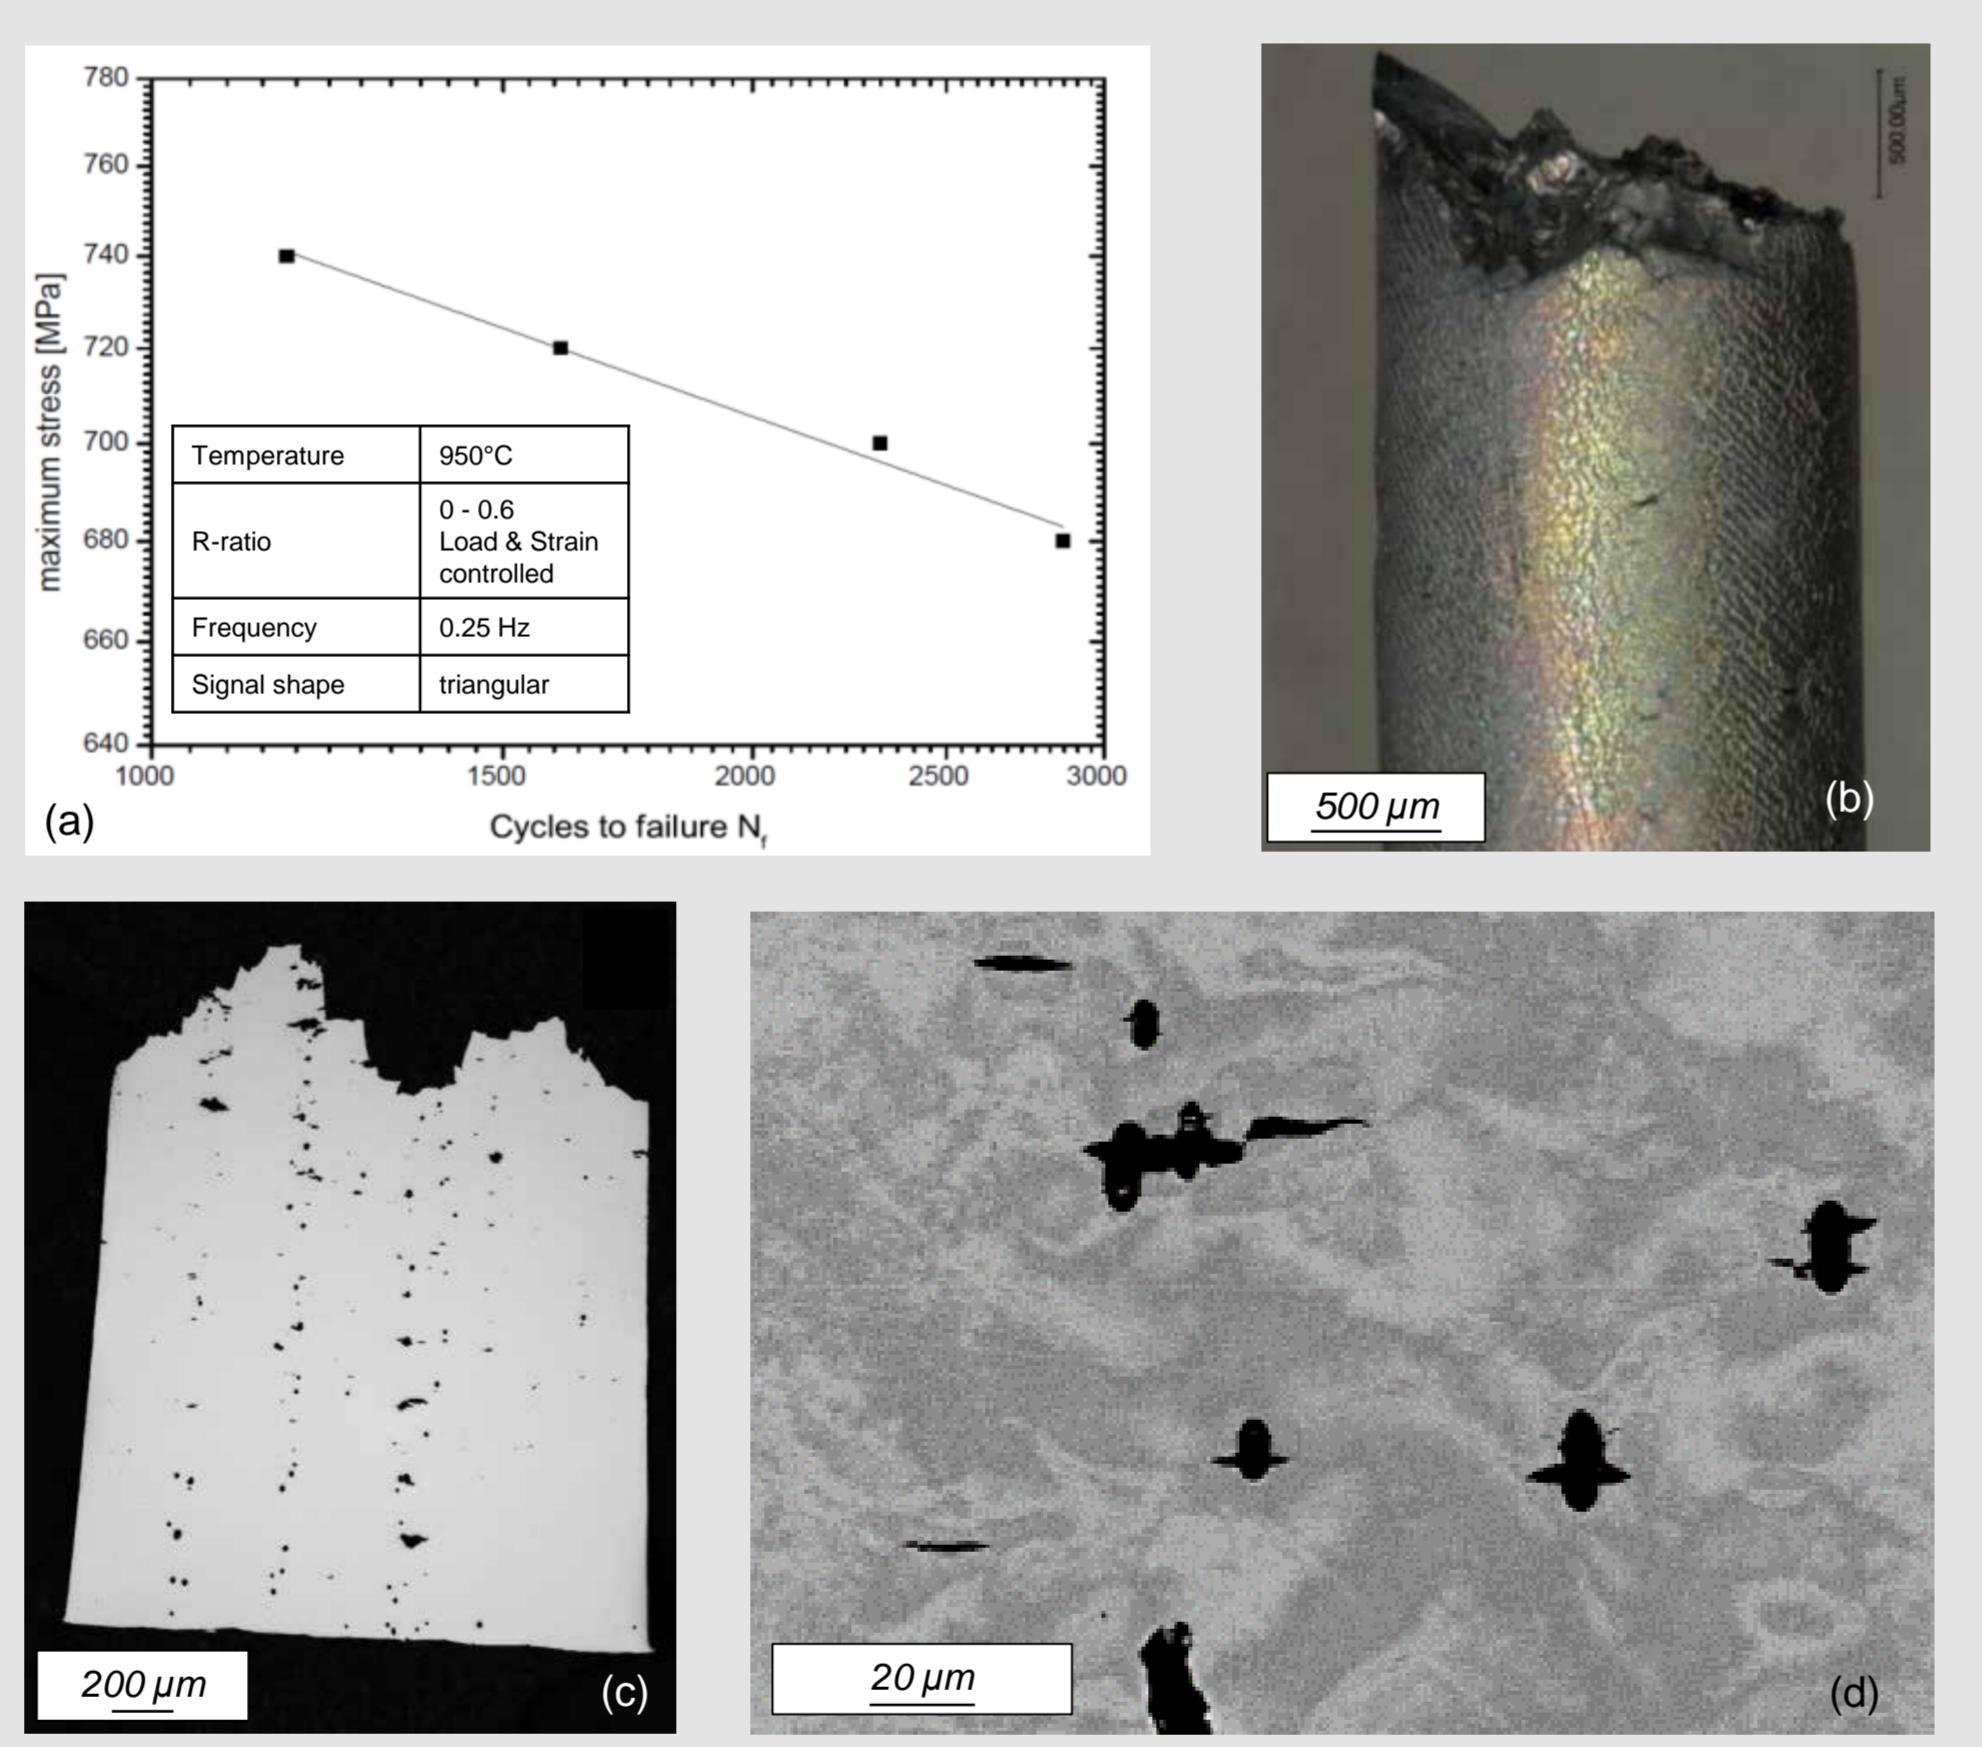
LCF parameters and lifetime are displayed in Fig. 2(a). Fractured specimens show slip steps at the surface due to slip along {111} planes, Fig. 2(b). Length sections reveal aligned interdendritic pores, acting as crack initiation sites, Fig. 2(c, d).

Figure 2: Lifetime data, fractured specimen, and crack initiation at interdendritic pores

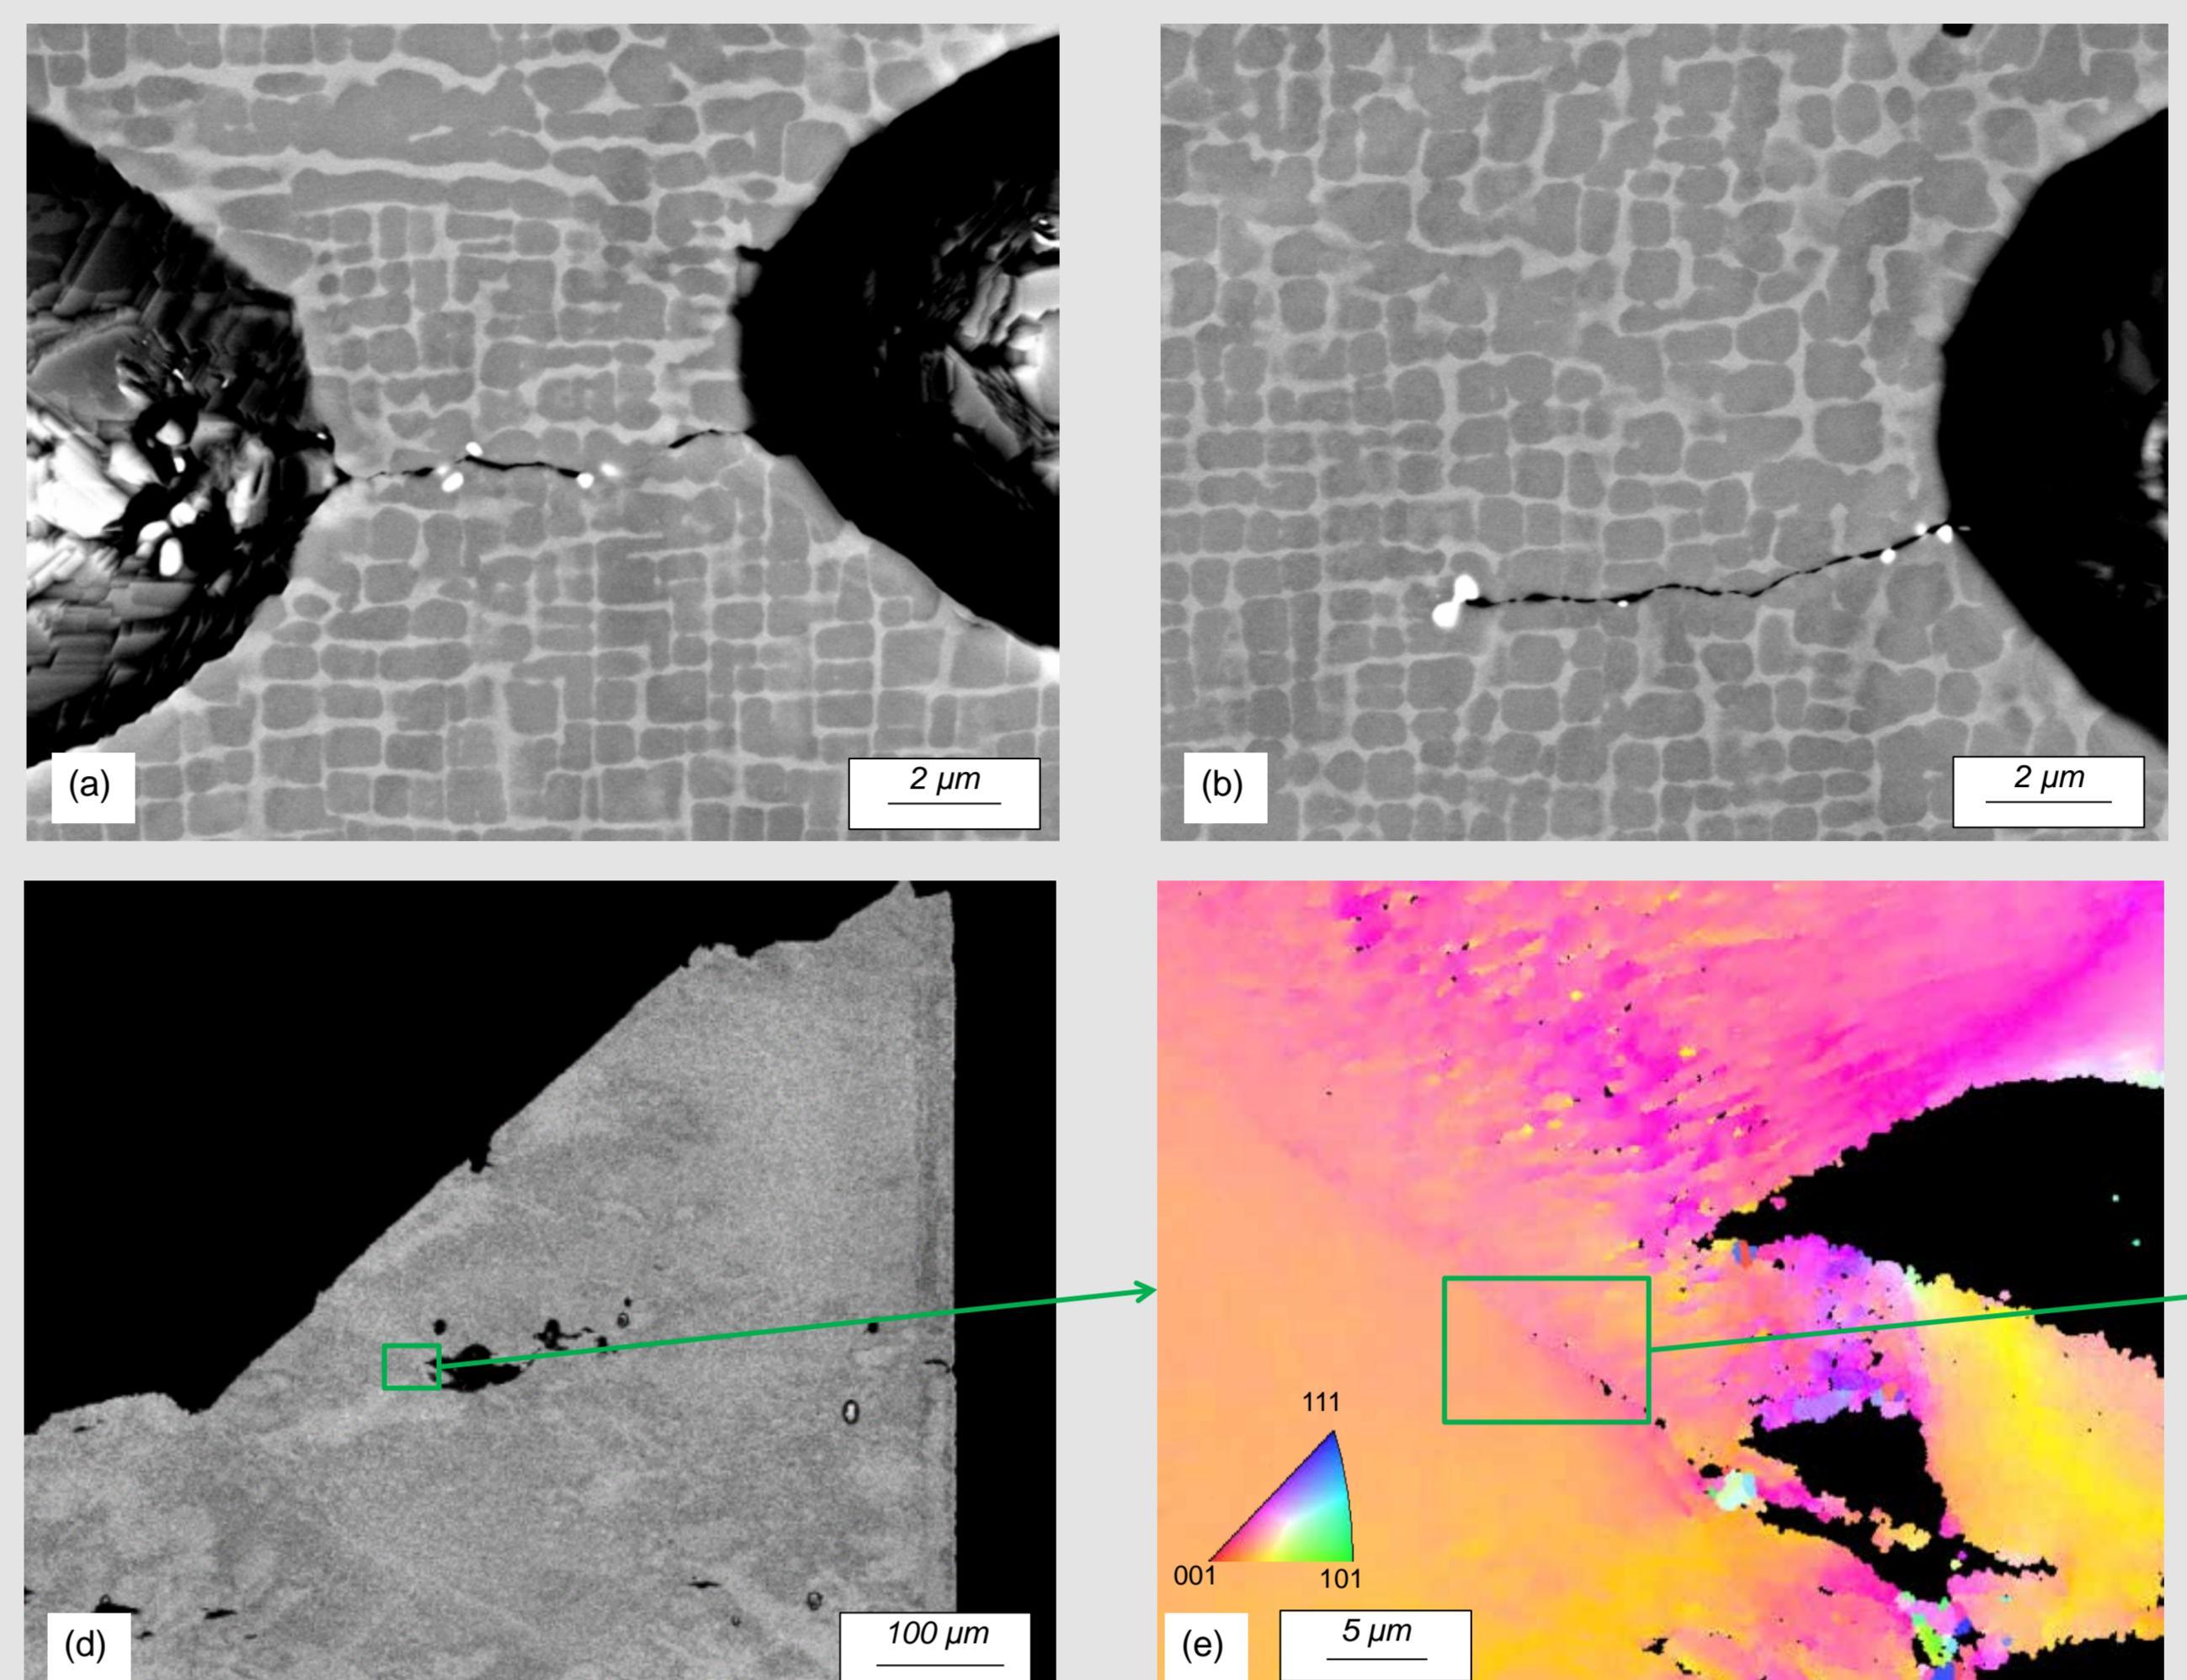
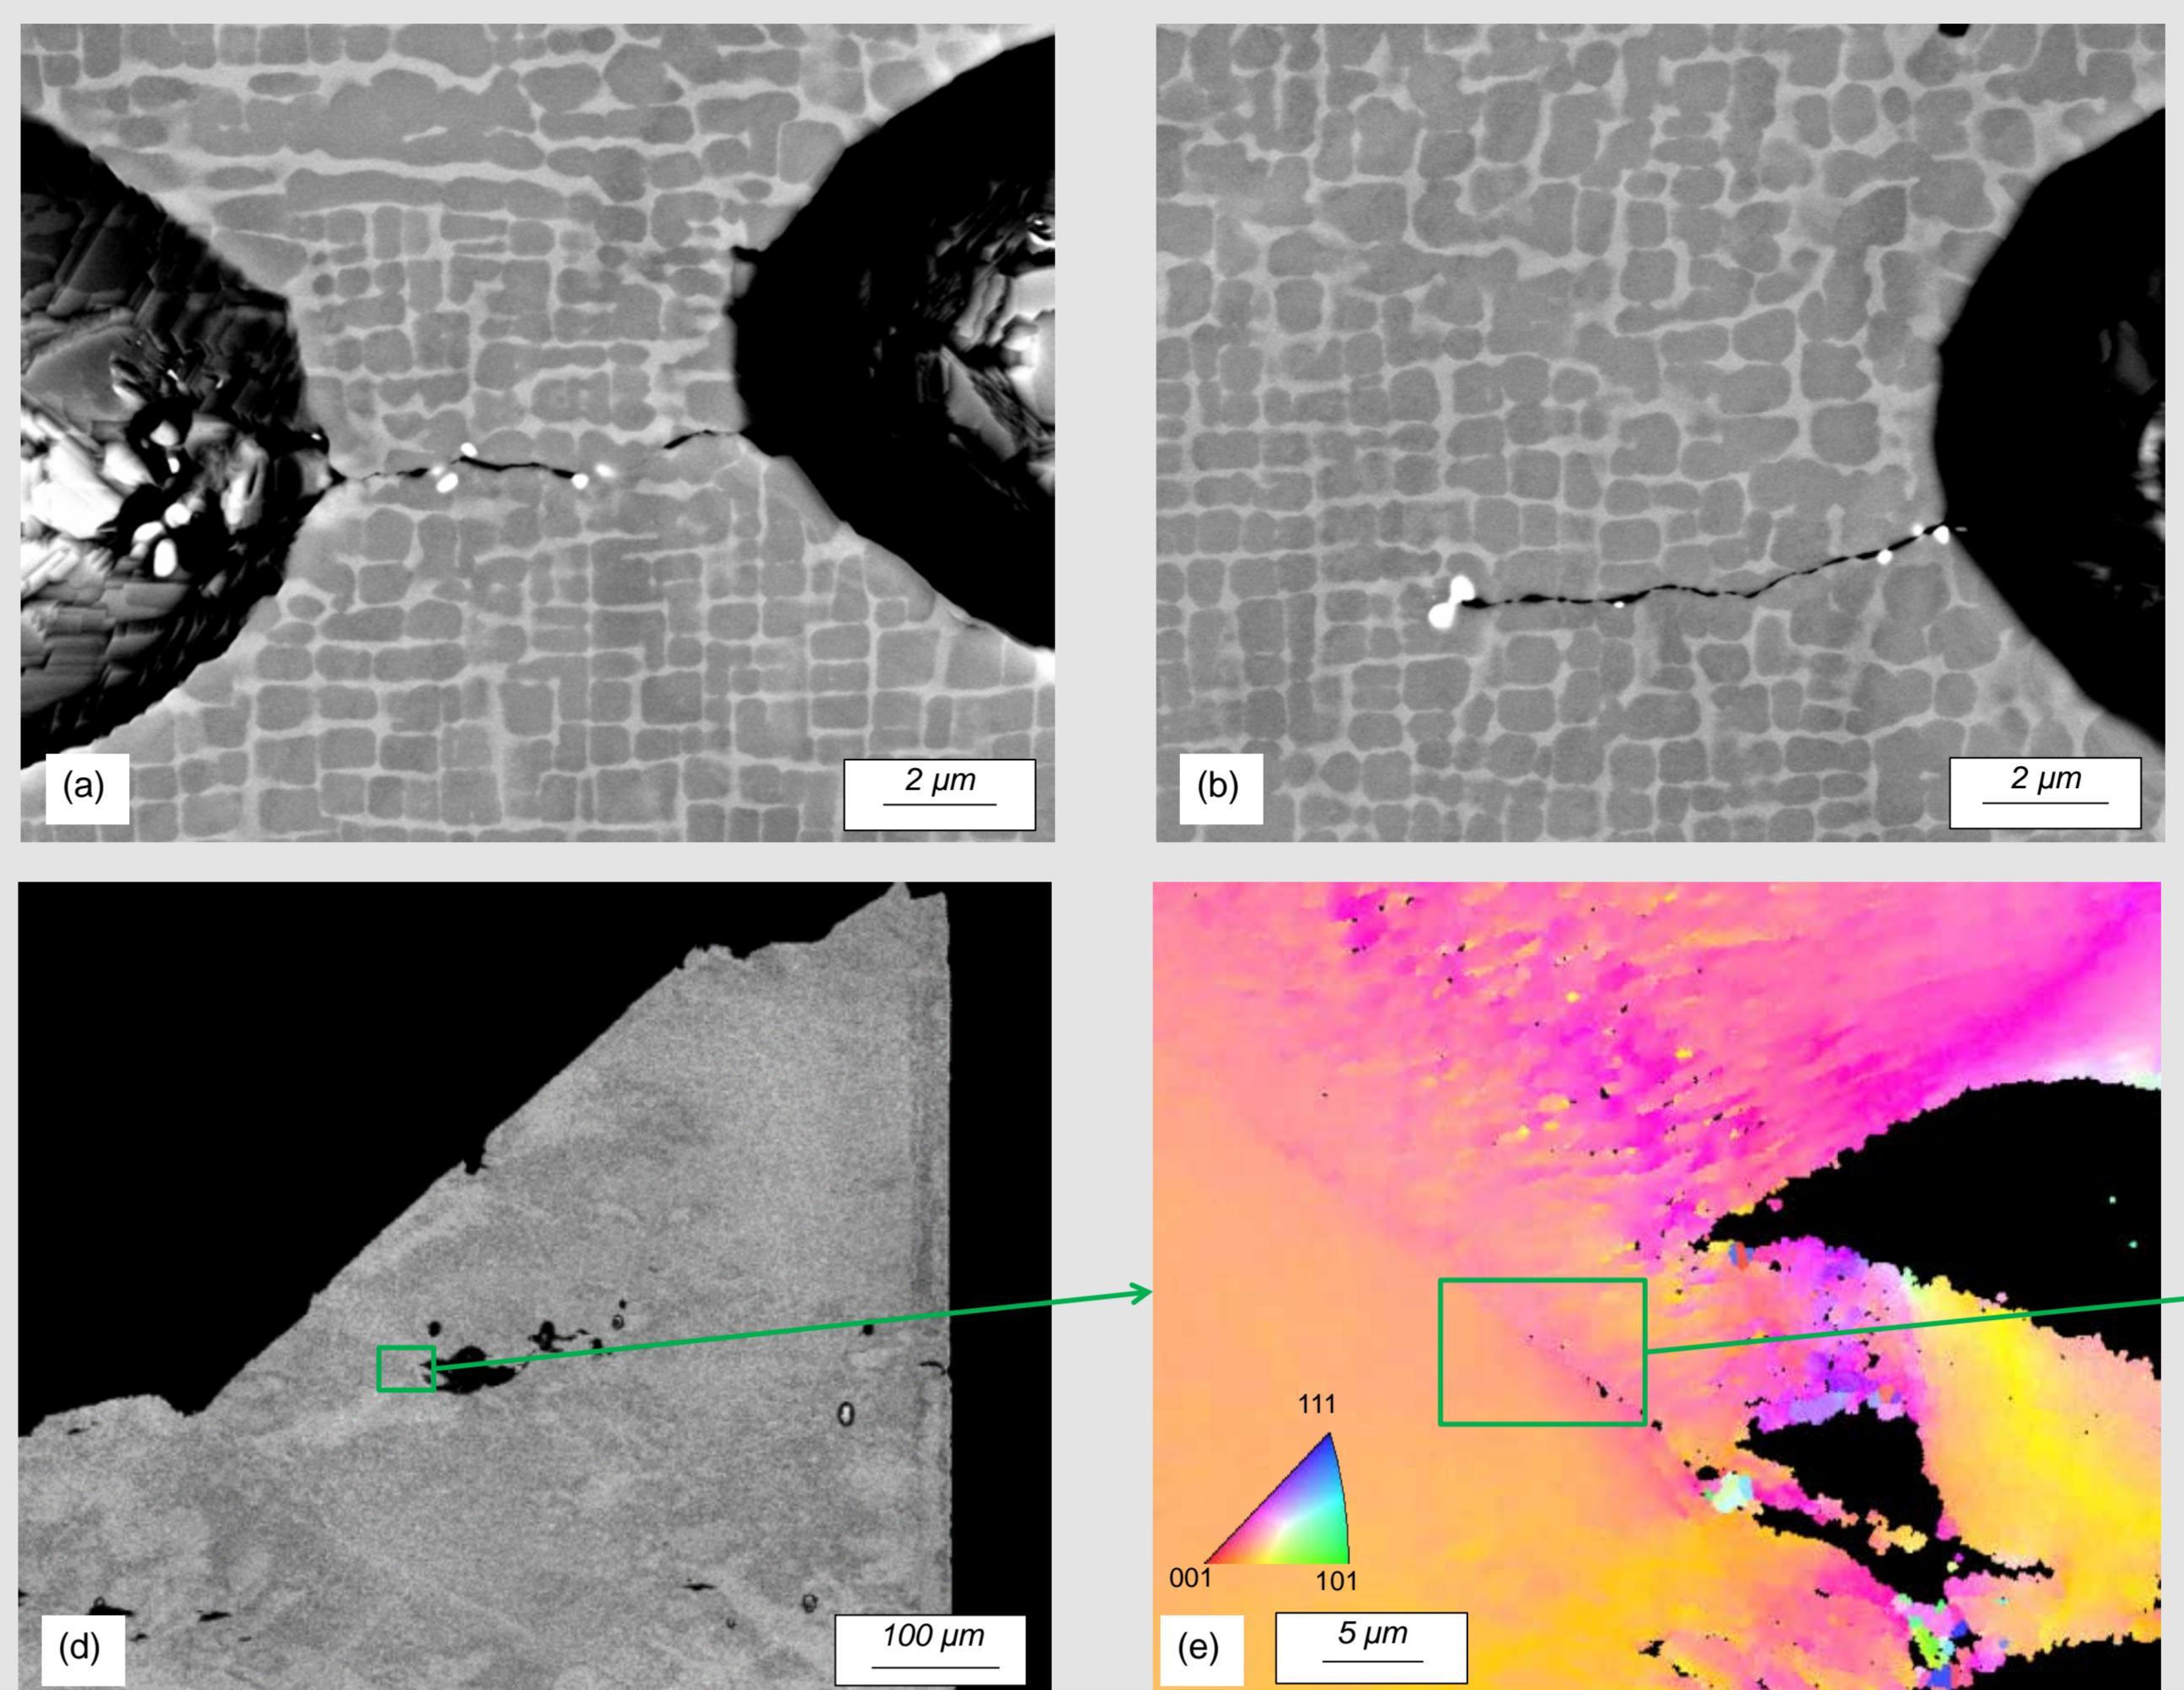
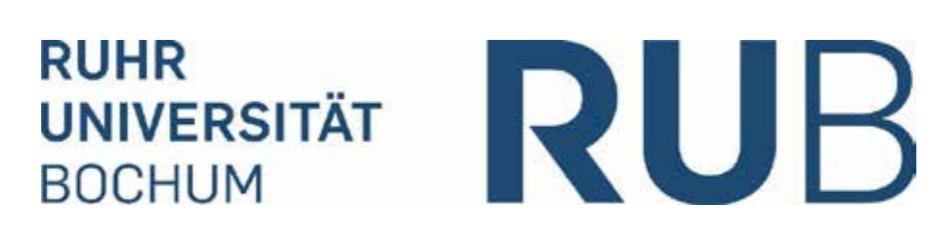
Crack propagation occurred either through γ channels perpendicular to the load, Fig. 3 (a, b) or along {111} planes, Fig. 3(f). At pores, slip bands, and cracks or near the specimen surface precipitates are found (Fig. 3 (a-c, f), showing high concentration of Co, Cr, Re, and W, which is characteristic for topologically closed packed (TCP) phases [1, 2].

Figure 3: Crack paths and formation of TCP phases

During formation of slip bands, γ precipitates are sheared, and subsequently cracks can open, Fig. 3 (f). Shearing is accompanied by crystallographic misorientation, as displayed by preliminary EBSD imaging, Fig. 3(e). Details of sheared γ/γ' microstructure and probably newly formed TCP-phase are shown in Fig. 4 (a, b). Especially near the surface, TCP phases occurred aligned along slip planes but without slip bands or sheared γ '-precipitates, Fig. 3 (c).

Stress concentrations resulting in elevated local strain seem to promote TCP precipitation [3]. TCP formation entails depletion of solid solution hardening elements of the y-phase with deleterious effect on creep properties [4] and negative influence on the fatigue properties [5]. However, own observations indicate that formation of TCP phases can reduce the crack propagation velocity since they seem to act as obstacles, causing slight deviations of crack paths at TCP phases, Fig. 3 (a, b).

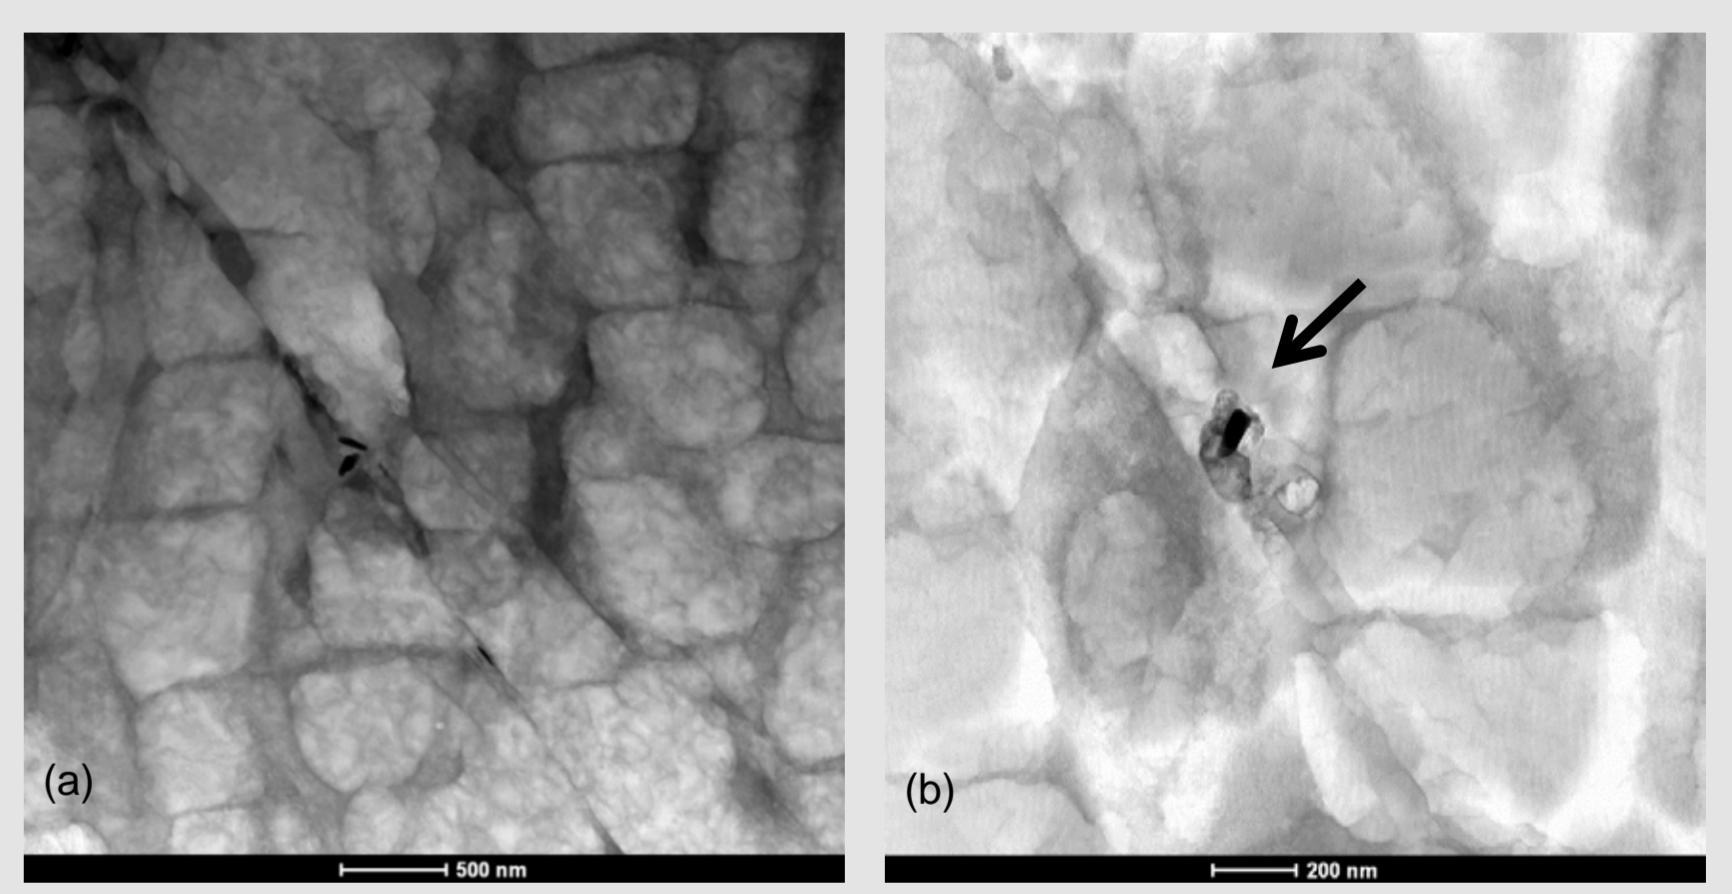
Figure 4: TEM images of slip bands with sheared γ'-cubes and TCP phases, (b) detail of TCP-phase
